## Coal Mine Fatal Accident 2005-20

Operator:	Arjay Mining, Inc.
Mine:	Adkins Branch Mine No. 1A
Accident Date:	December 15, 2005
Classification:	Roof Fall
Location:	Dist. 4, McDowell County, West Virginia
Mine Type:	Underground Coal Mine

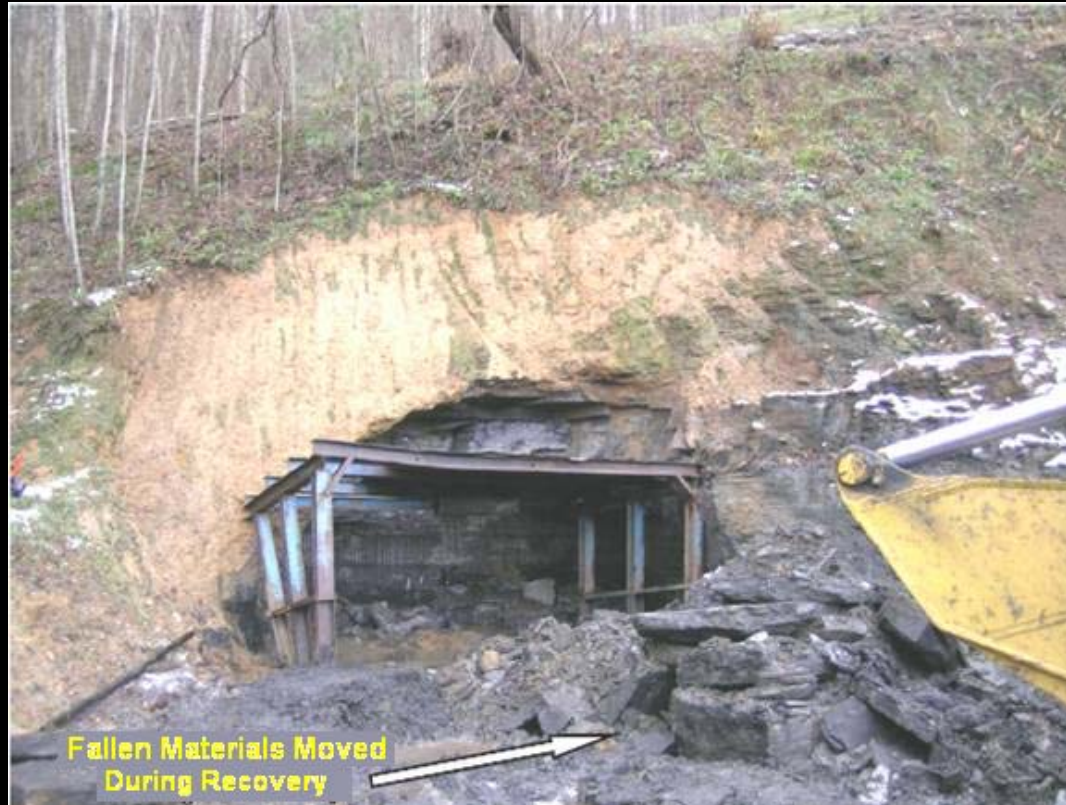
At approximately 12:40 p.m. on Thursday, December 15, 2005, a 35-year old roof bolting machine operator with 11 years mining experience was fatally injured in a roof fall accident. The victim was preparing to install the first row of roof support in the first cut taken from a highwall for a new drift opening when the mine roof collapsed. In an effort to avoid the falling rock, the victim moved in by the machine's automated temporary roof support (ATRS) towards the face, where he was struck by the falling material.

Causal Factor: The operator did not adopt effective designs or procedures to ensure the stability of the highwall. Similarly, the operator's ground control plan did not include methods to control existing hazardous conditions or precautions to keep persons from being exposed to these ground hazards. The highwall was not developed in consolidated, competent rock for a height sufficient to insure stability above the mine openings. Some areas of the highwall had been developed in dirt, on a near vertical angle, and were not stable. A bench and a diversion ditch had been developed in dirt and unconsolidated material above the entries. The disturbed material from the ditch construction was left in place on the bank above the bench and highwall. Portions of the dirt bench had fallen to the floor of the mine bench.

Corrective Action: Arjay Mining, Inc., submitted a plan to safely remove all mining equipment from the mine site. Riverside Energy Company, LLC., current owner of the mine site, does not plan to pursue any further mining at this site and plans to reclaim it.
